POOLING OUR ENERGY SAVINGS

FINAL REPORT

MAY 2015

***CITY OF DAREBIN'S
AQUATIC CENTRE
ENERGY EFFICIENCY
UPGRADES***

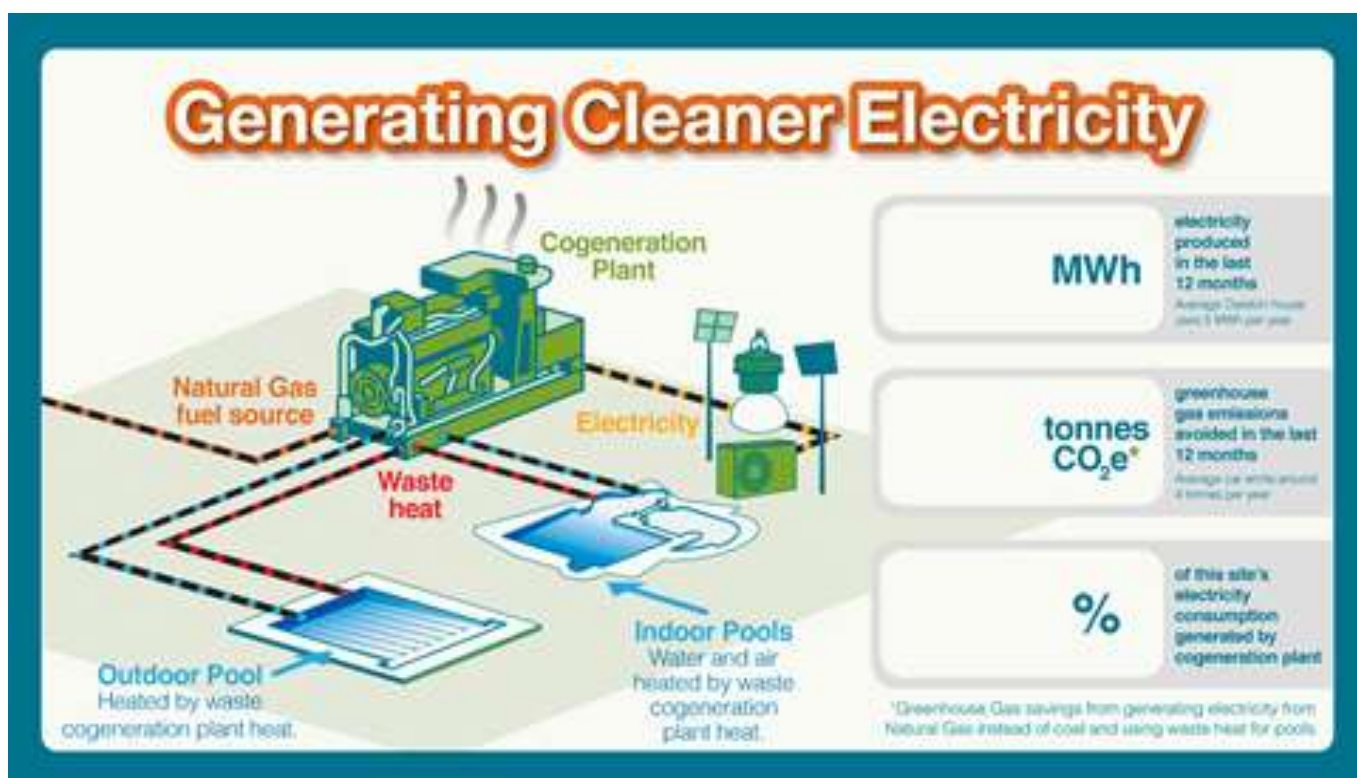
Figure 2 Schematic of cogeneration operation

Cogeneration is a system which generates two outputs which are usable. In this instance our cogeneration

systems involved using natural gas as the fuel source, with the two outputs being electricity from generator and heat from the engine. Every engine produces heat, usually this heat is considered a 'waste' or 'by-product' of the electricity generation. In applications such as aquatic centres and other operations with high thermal heat demand, this heat can be captured and used in the facility. With correct system integration, this 'free' heat will reduce the energy required from the existing heating system, thus reducing energy use, bills and greenhouse gas emissions of the heating load.

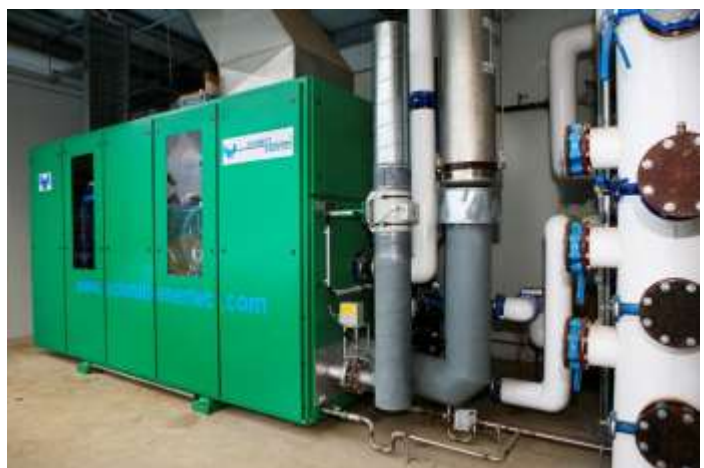
Photo 2 NARC cogeneration system

As a result of this process, reciprocating engines were selected for both sites as being the best value proposition.

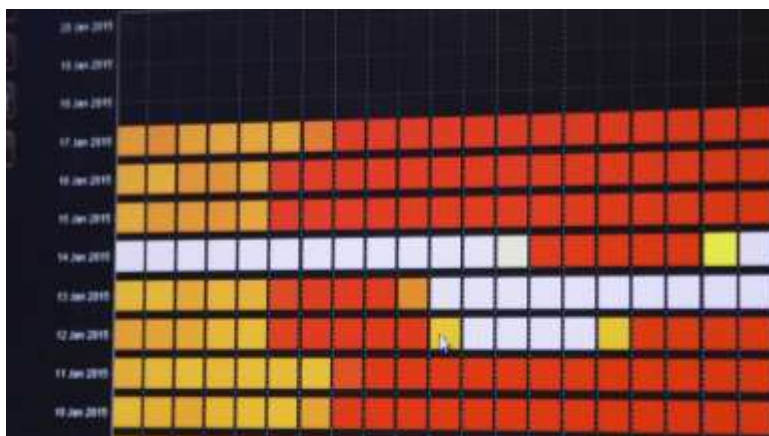
Photo 3 Screenshot cogen monitoring

An easily usable real time monitoring interface is an essential component to optimizing a cogeneration system.

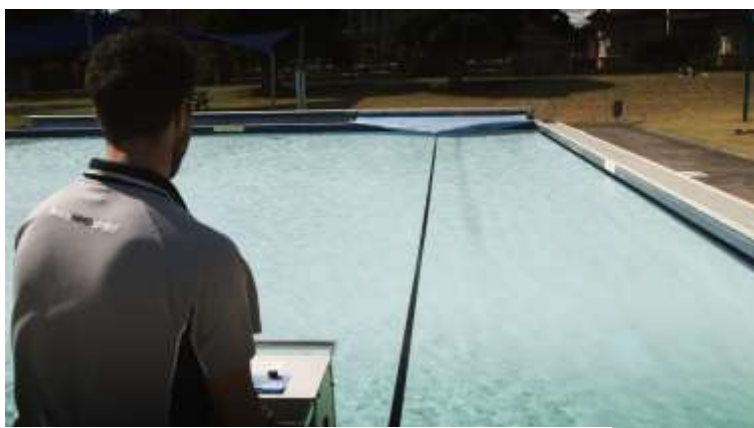
Photo 5 Blanket deployment

- Blankets should be fixed in place not on mobile frames. Having to manually wheel blanket rollers in to place and remove each morning would result in significant extra labour costs and also risk the occupational health and safety of staff.

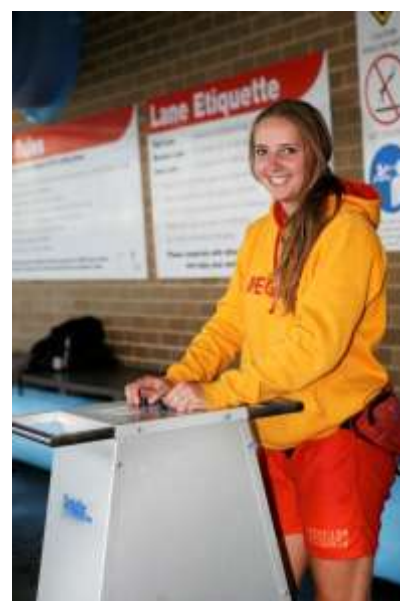
Photo 7 Staff member with electric winder

Another problem was encountered after the project was complete. This was due to user error. The electric 'slave' winder was damaged by a staff member using it inappropriately as they had not been trained. The issue was resolved by confirming with the centre management the importance of user training in addition to extra signage on equipment which was provided by the supplier to highlight correct usage techniques.

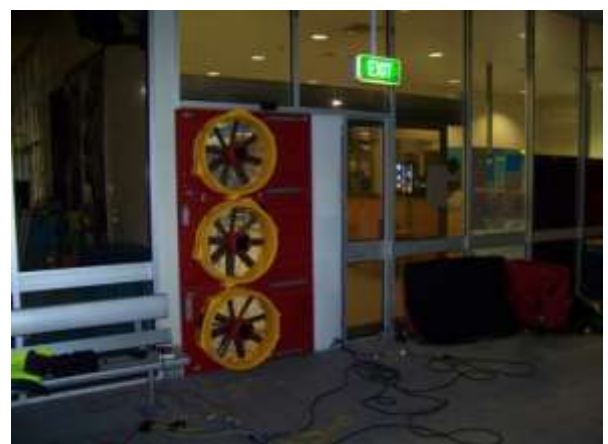
Photo 8 RLC air leakage testing

Draught sealing gaps is one of the simplest actions that can be taken to reduce energy use of a building. To seal the gaps around various windows we used foam strip and poly urethane gap filler. This was a very simple job process which could easily be undertaken by our Council building contractor. One of the surprising opportunities for significant energy savings was the leakage from the box gutters running all the way around the pool hall at RLC. In order to determine the opportunity for improvement, a specialist building air leakage contractor was engaged to test the building. The results were astounding. The testing indicated that the permeability rate was over 62 cubic metres per hour per square metre ($\text{m}^3/\text{hr}/\text{m}^2$) of envelope area, versus the target based on best practice benchmarks of under 10 ($\text{m}^3/\text{hr}/\text{m}^2$). With this result we were sure that significant savings could be achieved through reducing this air leakage.

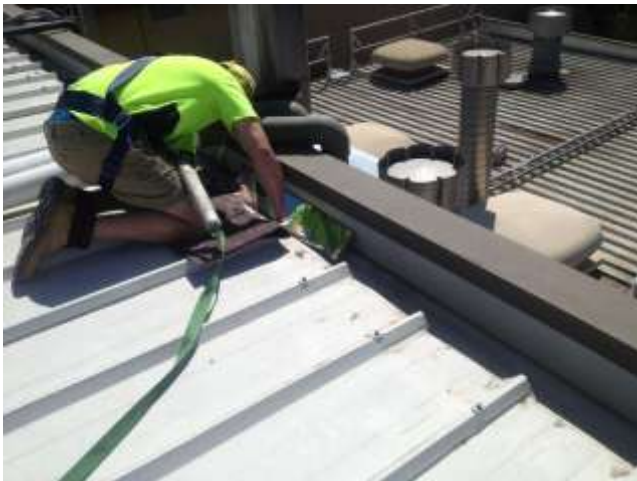
Photo 9 Sealing box gutter RLC

Investigations by Council's building contractor identified that the box gutter running the whole way around the pool hall was poorly sealed to building, with an average gap of around 5mm the whole way around. This added up to 1 square metre of gap, the same as having a 1 square metre window open all the time or 50 bricks missing from a wall! We engaged our building contractor to seal the gap the whole way around the building with polyurethane filler. In some parts the gutter did need to be pulled in to place using screws because the gap was too large for the sealer to be practical.

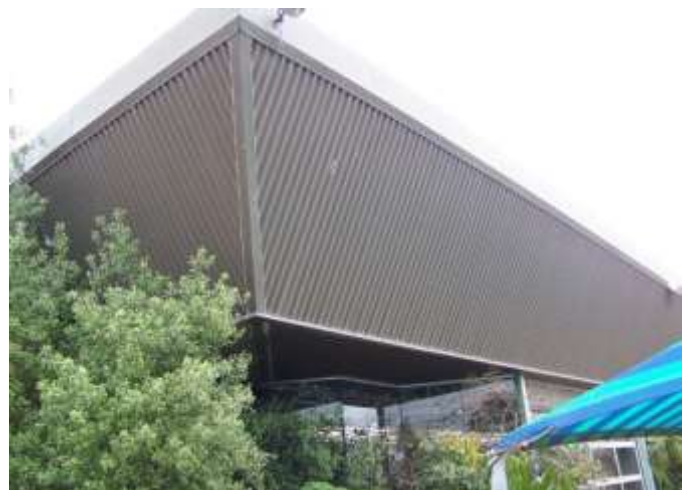
Photo 10 RLC facade

Our consulting mechanical engineer identified that due to the envelope design with corrugated sheets and flashing, significant air leakage was likely occurring under the metal flashing. The current upper metal wall around the pool hall was also identified as not being insulated which would be leading to significant energy loss.

A number of possible solutions were considered including sealing the gaps with some kind of filler. After meeting with Council's building contractor, mechanical engineer and consulting architect, it was deemed that it would be very difficult to access the areas. This would result in high risk to installers and would challenge the quality of the work. We identified that a product was available; Kingspan architectural wall panel (AWP). This could be retrofitted and included a high energy efficiency design with built in weather seals between the panels.

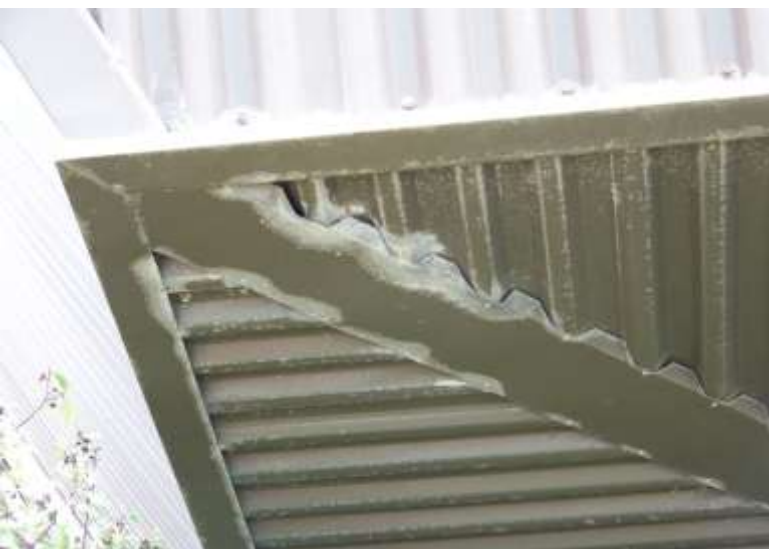
Photo 11 Air leakage evidence by corrosion

Due to the high amount of condensation forming on the inside of the building façade at RLC, the building materials were being damaged by this corrosive liquid. This corrosion as evidenced in Photo 11 leads to increased maintenance costs and materials required for repair and replacement. The new insulated panels to not form condensation on the inside which means we will see reduced repair and maintenance costs.

With detailed consultation between our builders, technical experts, product supplier and the site manager, it was agreed to proceed with the Kingspan product to replace the existing metal façade material.

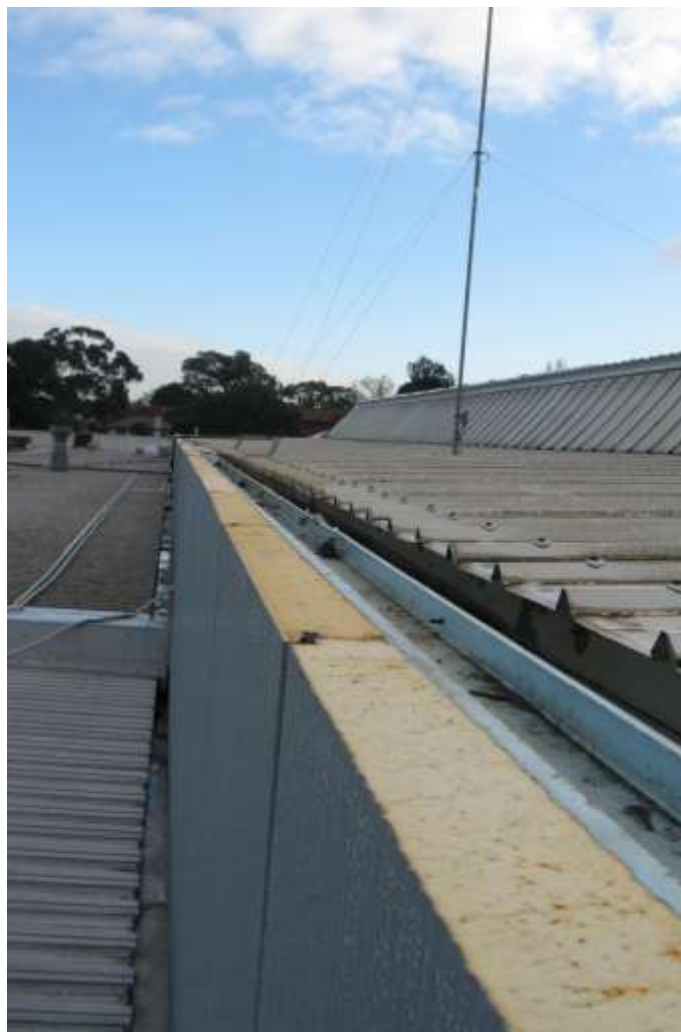
Photo 12 Insulated wall panel

With consultation with our architect, Council's builder and the Kingspan technical representative, detailed construction drawings were created to clearly specify the work required. Council's building contractor was engaged to undertake the works as a 'turn-key' contract. With engagement from centre management, we were able to undertake the works without any closure of the centre through careful works scheduling and a focus on safety procedures.

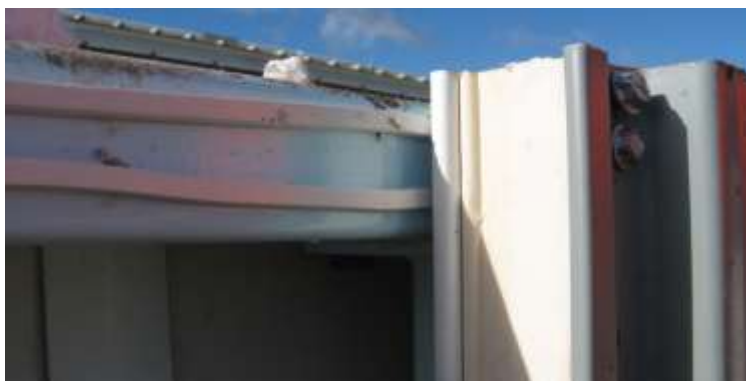
Photo 13 Sealing tape strips under panels

Although we did not have any technical issues with the installation, we did experience major installation issues. As part of our quality control procedure, the specification clearly detailed the photographic evidence which was required to demonstrate compliance with the specifications; the contractor did not provide this evidence during construction. In particular, this was required to verify that concealed works such as the sealing tape and the fixings were installed as per the

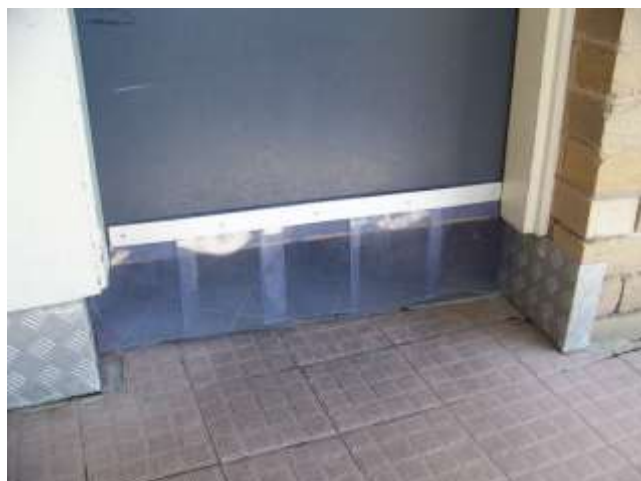
Photo 14 Change room wind barriers strips

A number of different approaches were taken to seal doorways. As indicated in Photo 14, simple PVC strips were installed on the NARC change room doors to reduce cold air flowing through from the nearby front doors. Other doors with more standard undercuts were fitted with high quality commercial door seals.

In regards to the NARC change room doors, initially we planned to install longer doors to reduce the undercut and fit commercial door seals. When we installed the first door we discovered that the floor was not level and the door would open without a certain amount of undercut. As a solution, we designed a PVC flap system which could be flexible with the floor level but also provide a reasonable barrier to unwanted air leakage and draughts. It was a simple, low cost and effective solution.

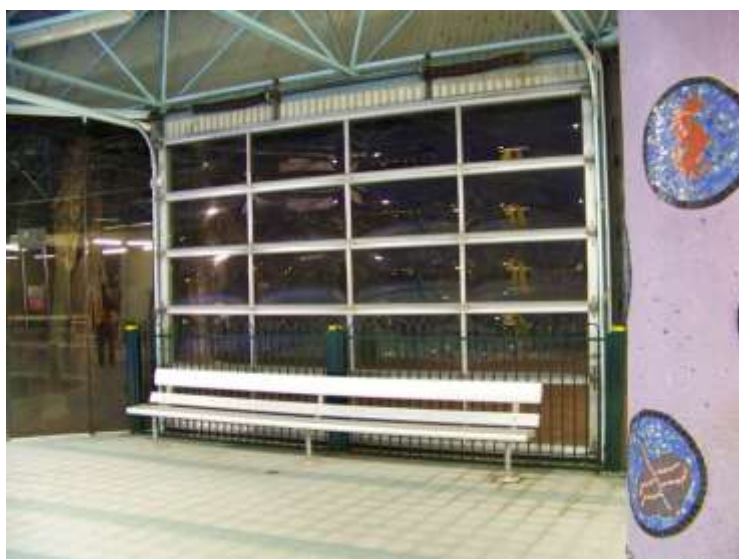
Photo 15 RLC existing pool hall door

presented by the old aluminum single glazed doors at the RLC. The five doors around the pool hall had large gaps between the panels of the door, as well as around the perimeter. This resulted in significant heat loss from the pool hall as identified by our consulting mechanical engineer. As well as the air leakage losses, the doors also had extremely poor thermal performance, being aluminum with single glazed clear acrylic paneling.

We assessed the options to retrofit these doors with better seals and sealing the gaps between the panels. After a number of meetings with builders and investigations of products available, we formed the opinion that there would not be a solution which we could be sure would deliver the quality of sealing we were trying to achieve.

Even if we could identify a way to seal the doors, the doors would still have very poor thermal performance due to the aluminum framing and single glazing. Another consideration was advice by centre management that the doors were already very old and starting to fail, so any upgrade would probably have limited life with the doors being at 'end of life'. With all these considerations in mind we agreed the best way forward would be to install new doors with high energy ratings and long life to realize the energy savings.

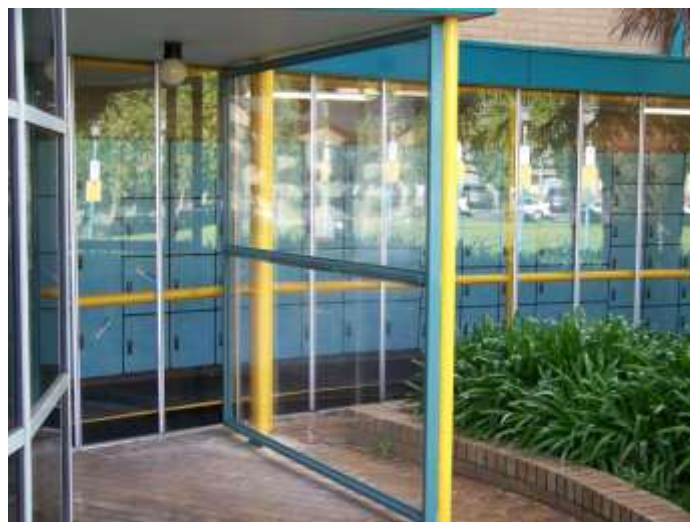
Photo 17 NARC front door wind barrier

At NARC a major source of air leakage was the two automated front doors. These doors did not have any 'air-lock' system. Such a system could not be implemented due to the lack of separation space required to enable effective use of dual door air locks. The centre staff had advised us that the air infiltration through these doors was significant as evidenced by the chilling air blowing in and the amount of leaves and debris which could be seen inside these doors. As a relatively simple response, we designed a wind barrier screen to be located outside the existing entry and exit doors. This measure does not provide an air tight seal by any means, but does disrupt the direct airflow, particularly from the south-west cold winds.

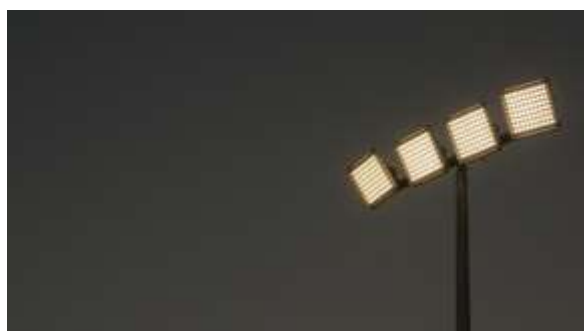
Photo 18 NARC LED outdoor pool LED

All the high bays and flood lights were replaced with LED technology as this technology is expected to deliver significant energy and maintenance savings. With long operating hours of aquatic

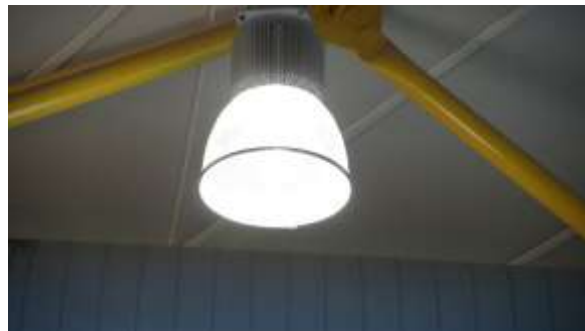
Photo 19 NARC indoor pool LED

At the NARC indoor pool, the main challenge we faced here was that despite all of our efforts in confirming the lighting design with the supplier, when we installed the lighting, we found that the light levels were significantly lower than the Australian Standards and the level submitted in the suppliers tender. Our risk control strategy was crucial at this point to;

Particularly at NARC, all of the indoor pool hall lights had reached end of life. With about 14 lights, mostly over the pool water surface, the cost to replace these would be very high. At the time of this upgrade some lights had already failed and due to the age and corrosion, they could not be opened to repair. By undertaking this LED upgrade we have avoided significant future costs to replace this lighting.

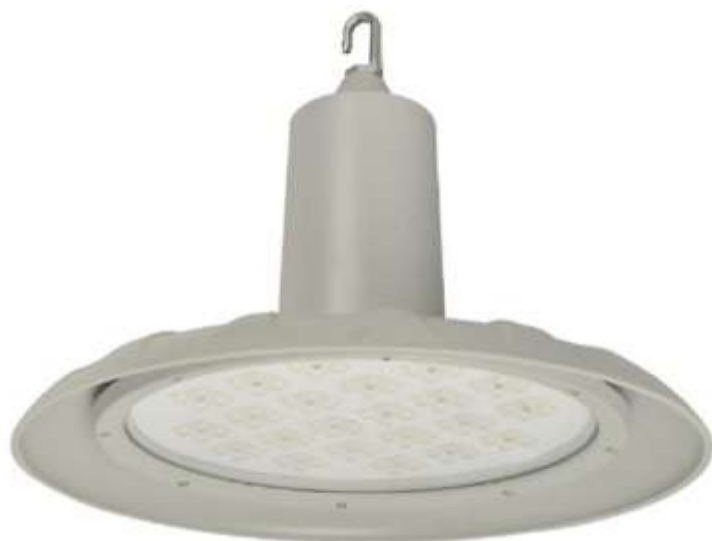
Photo 20 RLC 140 watt LED high bay

to access challenges. The existing metal halide lights were expected to have a life of around 12,000 hours, whereas the LED lights are expected to function at the required light level for at least 30,000 to 50,000 hours.

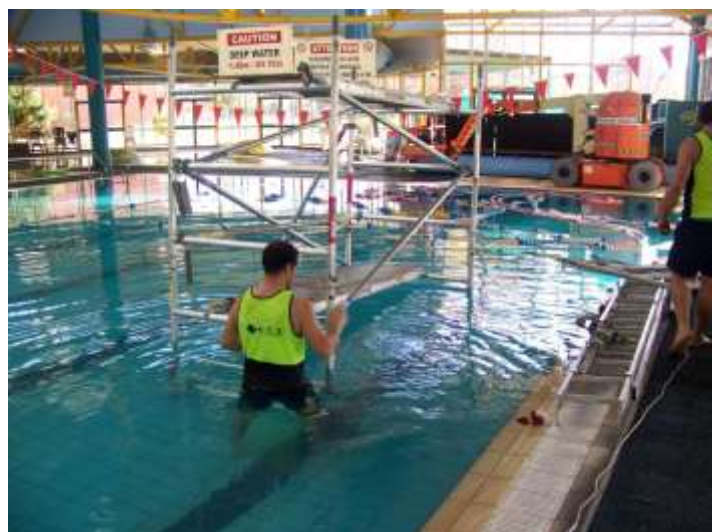
Photo 21 Challenging installation over pools

A particular challenge for aquatic centres is to address the method of safely changing lights when they are located above the pool, with associated risks of working near water and access for lifting equipment. With a project team including the contractors and site managers, we were able to fully understand the issues and risks involved and then

agree on an approach which was acceptable to all parties. This involved a combination of scaffold in the pools and poolside lifters.

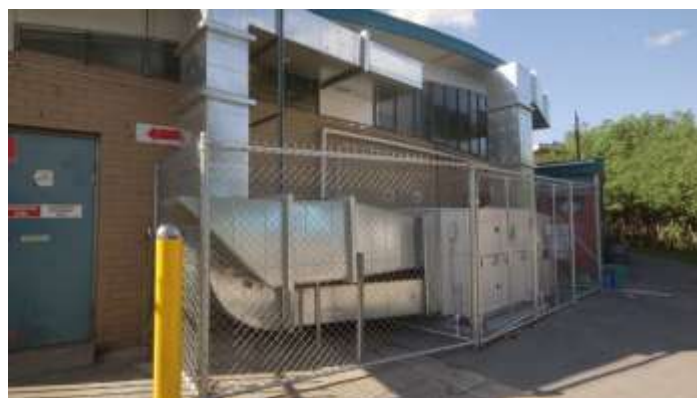
Photo 22 NARC Heat recovery system

The change rooms at NARC were heated by an old gas fired boiler which then reticulated hot water to an air handling unit. One hundred per cent fresh air was drawn in at all times with 100% exhaust of the supply air. The impact of this is that in Melbourne, the gas boiler would be required to operate most of the year due to the low ambient temperatures. The system operated every day of the year, 24 hours a day. In addition to the energy use, the conditions in the change room were always very cool despite the heating system being in operation. The gas unit was decommissioned and replaced with a higher efficiency electric heat pump system. We identified that due to the positioning of the supply and exhaust air vents, which were very high, the warm heated air was travelling directly from the supply air outlet to the exhaust air inlet. This resulted in minimal heating effect of the patrons at floor level. The technology we used to improve the performance and comfort of the this system was,

- Heat recovery ventilation system. This system captures up to 75% of the heat from the exhaust air and uses it to pre heat the incoming fresh air. This provides a system which still delivers 100% fresh air, which is important in change rooms for mould and odour control, but uses a fraction of the energy. This system is an electric heat pump system with variable speed drives on the fans.

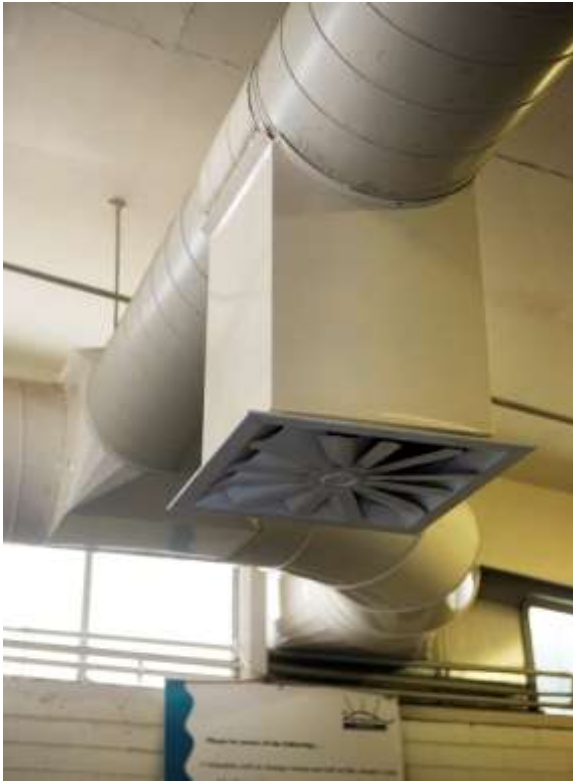
Photo 23 NARC new supply air droppers

- To improve the delivery on warm air to the ground level, outlet ducts were modified to direct the air down to the ground level, with swirl diffusers being used to optimise the mixing of warm air.
- Our consulting mechanical engineer confirmed that the ventilation should not need to run 24/7. To establish control of this, we installed a building management system with remote access back to Council's head office. The Climate Change Action officer can monitor the system for performance and easily fine tune the operating schedule to maximise energy savings while ensuring user amenity is maintained.

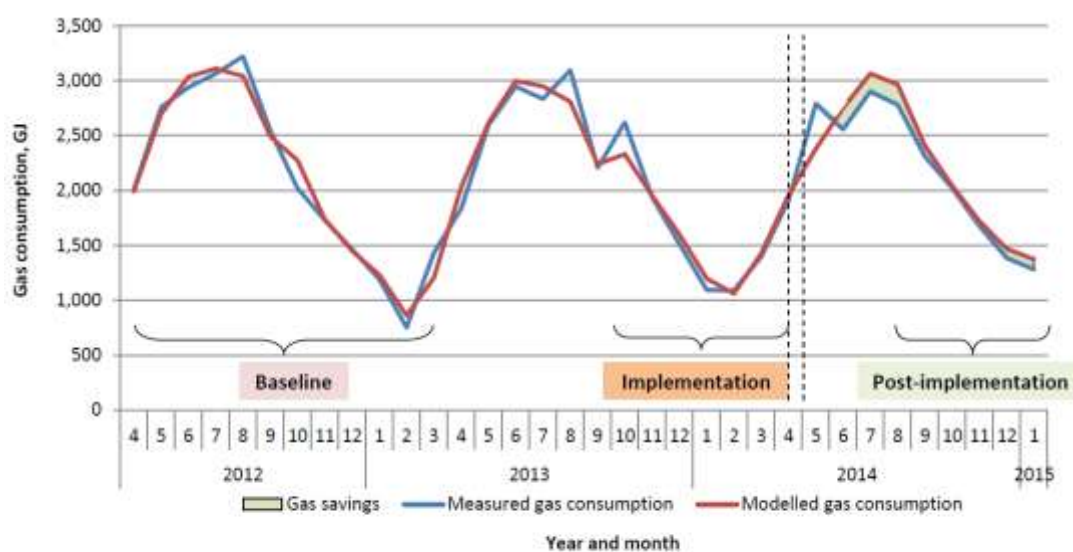
Figure 2: NARC - Baseline and post-implementation of thermal pool blankets, gas consumption

Figure 4 Pool Blanket savings - extract from auditor report

Based on this finding, we are confident that the pool blankets have delivered savings in the region of the original estimation.

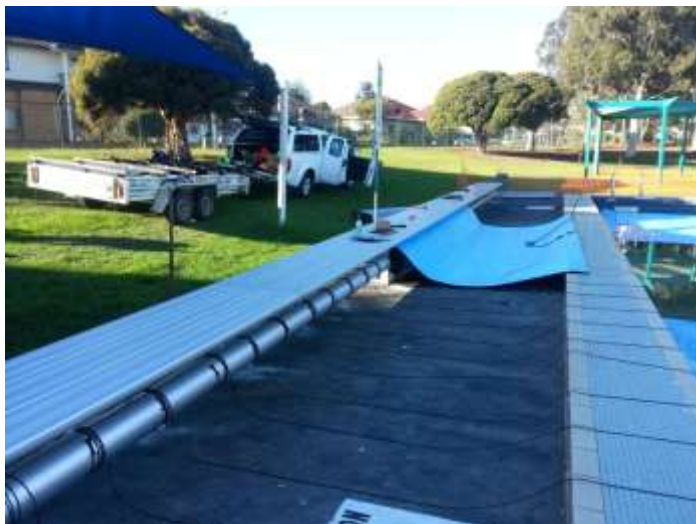
Photo 30 Installation outdoor pool seating above blankets

As well as the financial benefit of the avoided future cost of installing new seating, the blankets have provided an immediate benefit of more seating for people when taking children for swimming lessons. This seating is very well used.
